**Intel 450KX/GX PCIset
Specification Update
82454KX/GX (PB)
82453KX/GX (MC)
82452KX/GX (DP)
82451KX/GX (MIC)**

Release Date: April 1998

Order Number: 243109-014

The Intel 450KX/GX PCIset may contain design defects or errors known as errata which may cause the product to deviate from published specifications. Current characterized errata are documented in this Specification Update.

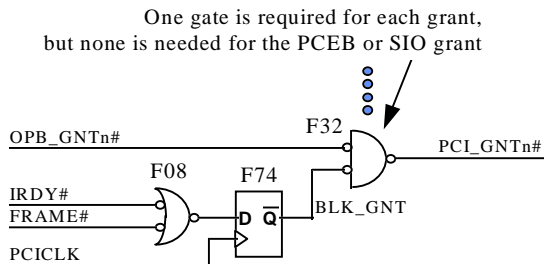
PROBLEM: During an inbound posted write burst, the 82454 PB may use the same data buffer for two adjacent transactions. This causes the first write to use and deallocate the data from the second write, corrupting data

IMPLICATION: Enabling inbound write posting may cause data corruption followed by a system hang. Disabling inbound write posting may result in significant I/O performance loss.

This arbiter must not perform overlapped arbitration. One way to ensure this is to implement the circuit described below, external to the arbiter. The actual workaround involves waiting for a bus idle before allowing a new grant to be issued. The IOQ depth must still be set to 1, and 2:1 interleaving must be used, to work around other errata which may surface when inbound write posting is enabled (even with this workaround). Note that this latter restriction requires at least 4 SIMM DRAM modules to be loaded at all times.

This following circuit is an implementation of the described workaround:

This workaround will allow inbound write posting to be enabled on A2 450KX PCISet silicon, and will not affect the functionality of B0 450KX/GX PCISet silicon, though a slight performance loss may result if this workaround is used with the B0 stepping. Enabling inbound posting by using this workaround is a significant performance enhancement for systems with A2 450KX PCISet silicon; refer to Intel's World Wide Web site for more details on the performance loss incurred by disabling inbound write posting (at URL <http://www.intel.com/procs/support/ppro/82450.htm>).

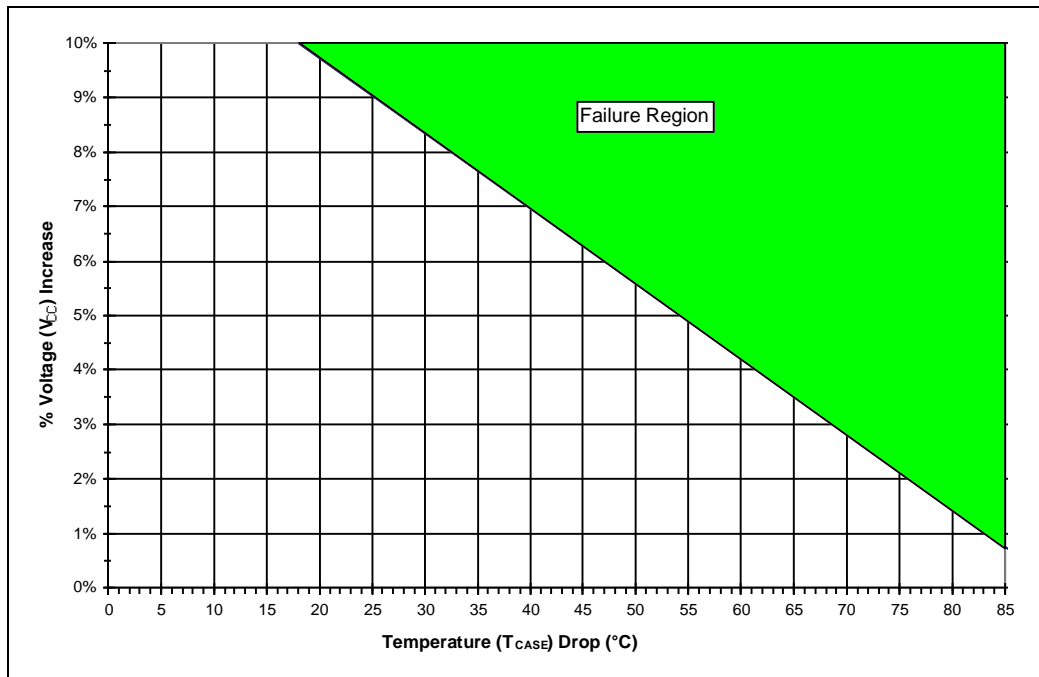
Figure 1. V_{CC} Increase vs. T_{CASE} Drop for DPLL Failure (Worst Case)

After a device has undergone a hard reset of the DPLL (via the PLLRST pin), a drop in T_{CASE} accompanied by an increase in V_{CC} may cause this erratum to occur. The magnitude of the temperature drop and supply voltage increase required to cause this failure is graphed below:

IMPLICATION: If the T_{CASE} of any Intel 450KX PCIsset component is allowed to decrease by more than 18 °C after the point at which DPLL lock is obtained after a DPLL hard reset, a positive voltage swing may cause the component to lose its internal clock for 2 - 500 processor bus clocks. This may result in a system hang, lost data, or other unpredictable system failure (note that if the component is not processing commands or data for the time during which the internal clock is lost, no failure will be observed). The larger the temperature drop and/or voltage swing, the more likely the failure.

If V_{CC} swings from 3.3 V -5% to 3.3 V +5%, and T_{CASE} does drop more than 18 °C past the temperature at which the DPLL was reset, this erratum may occur. Similarly, if T_{CASE} transitions from 85 °C (at DPLL reset time) to 0 °C, a swing in V_{CC} of more than 0.5% may cause this erratum. Thus, maintaining a moderately constant T_{CASE} and V_{CC} will prevent this erratum, as per the graph above.

WORKAROUND: Ensure that the DPLL reset occurs during a period where the T_{CASE} is low and/or the V_{CC} is high relative to normal operational conditions (e.g., if the system is running at a high temperature and is powered down, allow it to cool before powering up again). Alternately, ensure that the system meets a restricted specification for changes in T_{CASE} and V_{CC} .

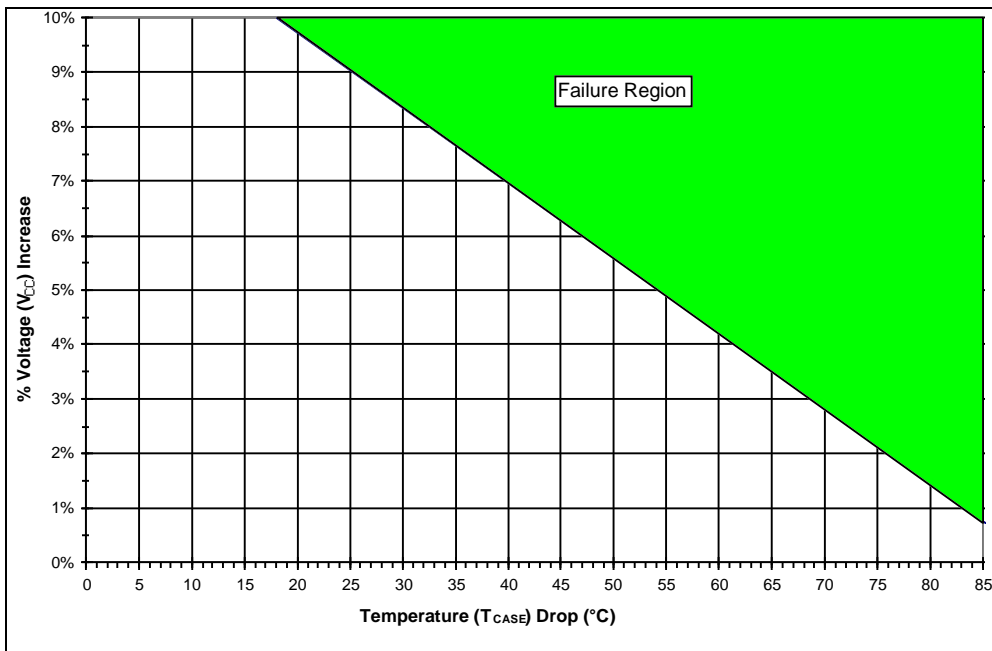
Figure 1. V_{CC} Increase vs. T_{CASE} Drop for DPLL Failure (Worst Case)

After a device has undergone a hard reset of the DPLL (via the PLLRST pin), a drop in T_{CASE} accompanied by an increase in V_{CC} may cause this erratum to occur. The magnitude of the temperature drop and supply voltage increase required to cause this failure is graphed below:

IMPLICATION: If the T_{CASE} of any Intel 450GX PCIset component is allowed to decrease by more than 18 °C after the point at which DPLL lock is obtained after a DPLL hard reset, a positive voltage swing may cause the component to lose its internal clock for 2 - 500 processor bus clocks. This may result in a system hang, lost data, or other unpredictable system failure (note that if the component is not processing commands or data for the time during which the internal clock is lost, no failure will be observed). The larger the temperature drop and/or voltage swing, the more likely the failure.
