**Intel 450KX/GX PCIset  
Specification Update  
82454KX/GX (PB)  
82453KX/GX (MC)  
82452KX/GX (DP)  
82451KX/GX (MIC)**

Release Date: August 1998

Order Number: 243109-015

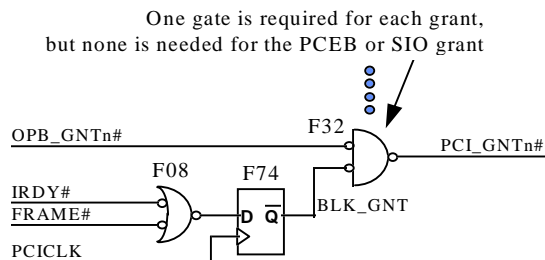
**PROBLEM:** During an inbound posted write burst, the 82454 PB may use the same data buffer for two adjacent transactions. This causes the first write to use and deallocate the data from the second write, corrupting data

**IMPLICATION:** Enabling inbound write posting may cause data corruption followed by a system hang. Disabling inbound write posting may result in significant I/O performance loss.

This arbiter must not perform overlapped arbitration. One way to ensure this is to implement the circuit described below, external to the arbiter. The actual workaround involves waiting for a bus idle before allowing a new grant to be issued. The IOQ depth must still be set to 1, and 2:1 interleaving must be used, to work around other errata which may surface when inbound write posting is enabled (even with this workaround). Note that this latter restriction requires at least 4 SIMM DRAM modules to be loaded at all times.

This following circuit is an implementation of the described workaround:

This workaround will allow inbound write posting to be enabled on A2 450KX PCIsset silicon, and will not affect the functionality of B0 450KX/GX PCIsset silicon, though a slight performance loss may result if this workaround is used with the B0 stepping. Enabling inbound posting by using this workaround is a significant performance enhancement for systems with A2 450KX PCIsset silicon; refer to Intel's World Wide Web site for more details on the performance loss incurred by disabling inbound write posting (at URL <http://www.intel.com/procs/support/ppro/82450.htm>).

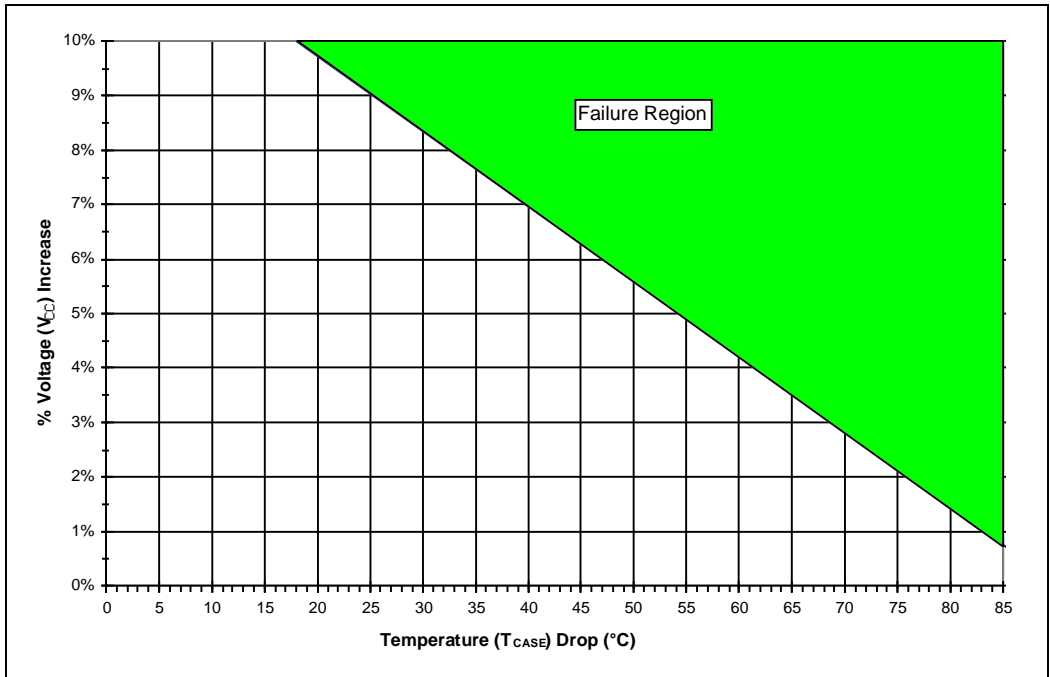
**Figure 1. V<sub>CC</sub> Increase vs. T<sub>CASE</sub> Drop for DPLL Failure (Worst Case)**

**PROBLEM:** Analysis of the DPLL (Digital Phase Lock Loop) units of the Intel 450KX PCIsset components has shown that a DPLL failure can occur during certain changes in temperature and/or voltage within the Intel 450KX PCIsset component specification, resulting in a loss of DPLL functionality for between 2 and 500 bus clocks.

The current specification states that the Intel 450KX/ PCIsset is operational over a T<sub>CASE</sub> range of 0 - 85 °C and a V<sub>CC</sub> range of 3.3 V ± 5%.

After a device has undergone a hard reset of the DPLL (via the PLLRST pin), a drop in T<sub>CASE</sub> accompanied by an increase in V<sub>CC</sub> may cause this erratum to occur. The magnitude of the temperature drop and supply voltage increase required to cause this failure is graphed below:

**IMPLICATION:** If the  $T_{CASE}$  of any Intel 450KX PCIsset component is allowed to decrease by more than 18°C after the point at which DPLL lock is obtained after a DPLL hard reset, a positive voltage swing may cause the component to lose its internal clock for 2 - 500 processor bus clocks. This may result in a system hang, lost data, or other unpredictable system failure (note that if the component is not processing commands or data for the time during which the internal clock is lost, no failure will be observed). The larger the temperature drop and/or voltage swing, the more likely the failure.

If  $V_{CC}$  swings from 3.3 V -5% to 3.3 V +5%, and  $T_{CASE}$  does drop more than 18 °C past the temperature at which the DPLL was reset, this erratum may occur. Similarly, if  $T_{CASE}$  transitions from 85 °C (at DPLL reset time) to 0 °C, a swing in  $V_{CC}$  of more than 0.5% may cause this erratum. Thus, maintaining a moderately constant  $T_{CASE}$  and  $V_{CC}$  will prevent this erratum, as per the graph above.

**WORKAROUND:** Ensure that the DPLL reset occurs during a period where the  $T_{CASE}$  is low and/or the  $V_{CC}$  is high relative to normal operational conditions (e.g., if the system is running at a high temperature and is powered down, allow it to cool before powering up again). Alternately, ensure that the system meets a restricted specification for changes in  $T_{CASE}$  and  $V_{CC}$ .

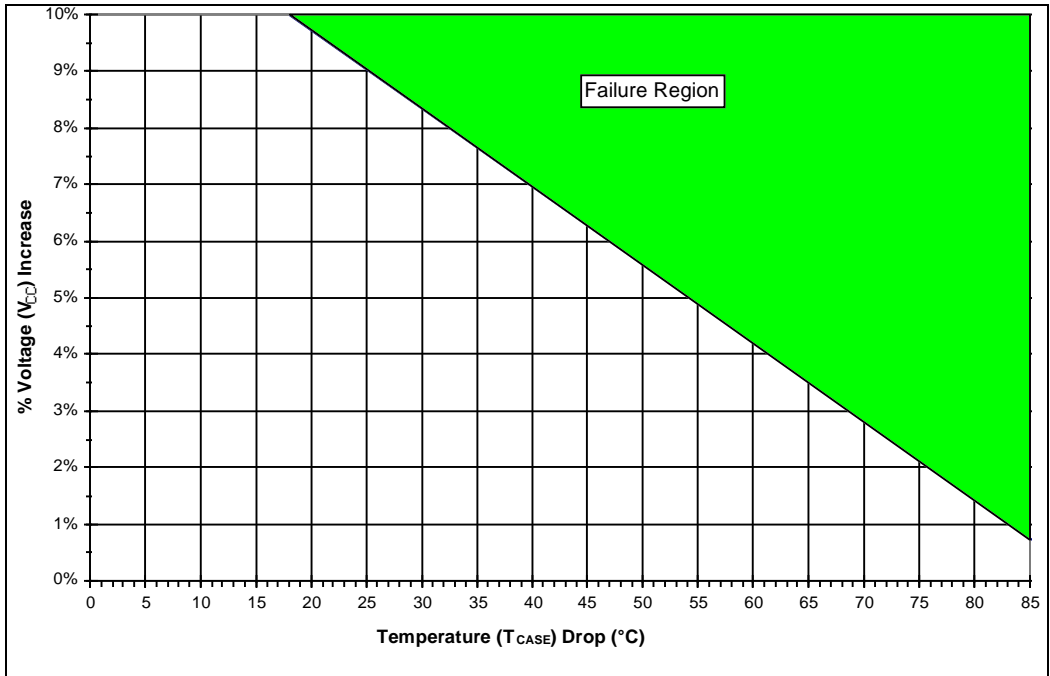
**Figure 1. V<sub>CC</sub> Increase vs. T<sub>CASE</sub> Drop for DPLL Failure (Worst Case)**

The current specification states that the Intel 450GX PCIsset is operational over a T<sub>CASE</sub> range of 0 - 85 °C and a V<sub>CC</sub> range of 3.3 V ± 5%.

After a device has undergone a hard reset of the DPLL (via the PLLRST pin), a drop in T<sub>CASE</sub> accompanied by an increase in V<sub>CC</sub> may cause this erratum to occur. The magnitude of the temperature drop and supply voltage increase required to cause this failure is graphed below:

**IMPLICATION:** If the T<sub>CASE</sub> of any Intel 450GX PCISSET component is allowed to decrease by more than 18 °C after the point at which DPLL lock is obtained after a DPLL hard reset, a positive voltage swing may cause the component to lose its internal clock for 2 - 500 processor bus clocks. This may result in a system hang, lost data, or other unpredictable system failure (note that if the component is not processing commands or data for the time during which the internal clock is lost, no failure will be observed). The larger the temperature drop and/or voltage swing, the more likely the failure.
