**Intel 450KX/GX PCIset  
Specification Update  
82454KX/GX (PB)  
82453KX/GX (MC)  
82452KX/GX (DP)  
82451KX/GX (MIC)**

Release Date: August 1998

Order Number: 243109-015

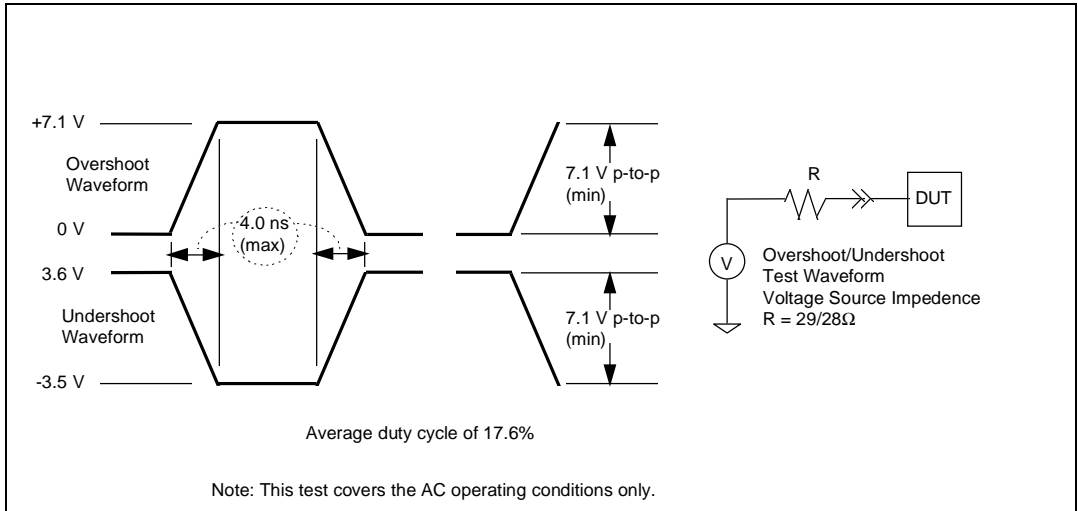
The following will be added to Chapter 4, Section 2.4, “Intel 450KX/GX Undershoot Specification,” in the *Intel 450KX/GX PCiset* datasheet, and the section will be retitled “Intel 450KX/GX Overshoot/Undershoot Specifications.”

The 3.3 V tolerant CMOS signals of the processor bus allow for the following maximum AC waveforms:

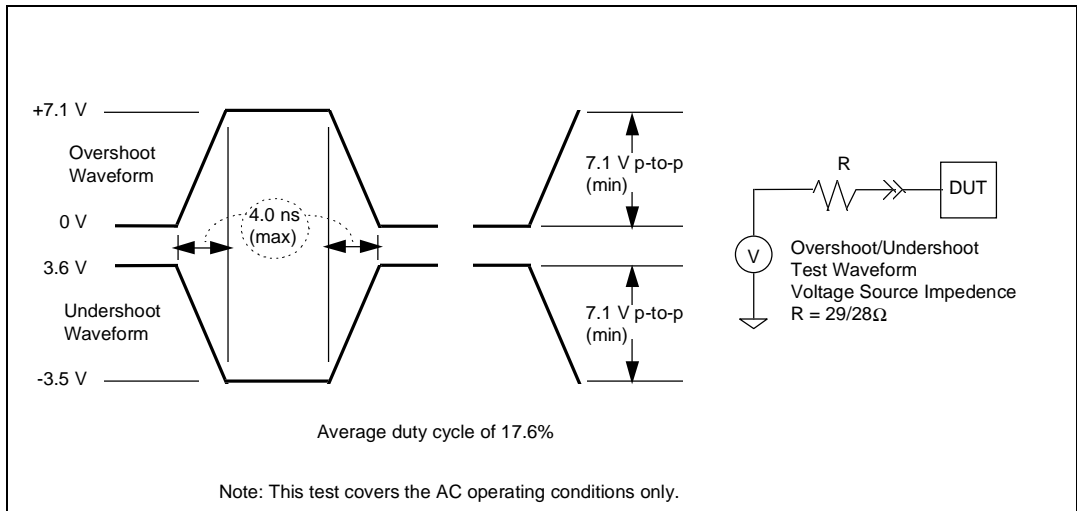
The following will be added to Chapter 4, Section 2.4, “Intel 450KX/GX Undershoot Specification,” in the *Intel 450KX/GX PCISSET* datasheet, and the section will be retitled “Intel 450KX/GX Overshoot/Undershoot Specifications.”

The 3.3 V tolerant CMOS signals of the processor bus allow for the following maximum AC waveforms:
